SPRING BROOK INTAKE DAM

NDI ID NO. PA-00450  
DER ID NO. 35-40

PHASE I INSPECTION REPORT  
NATIONAL DAM INSPECTION PROGRAM

APRIL 1980

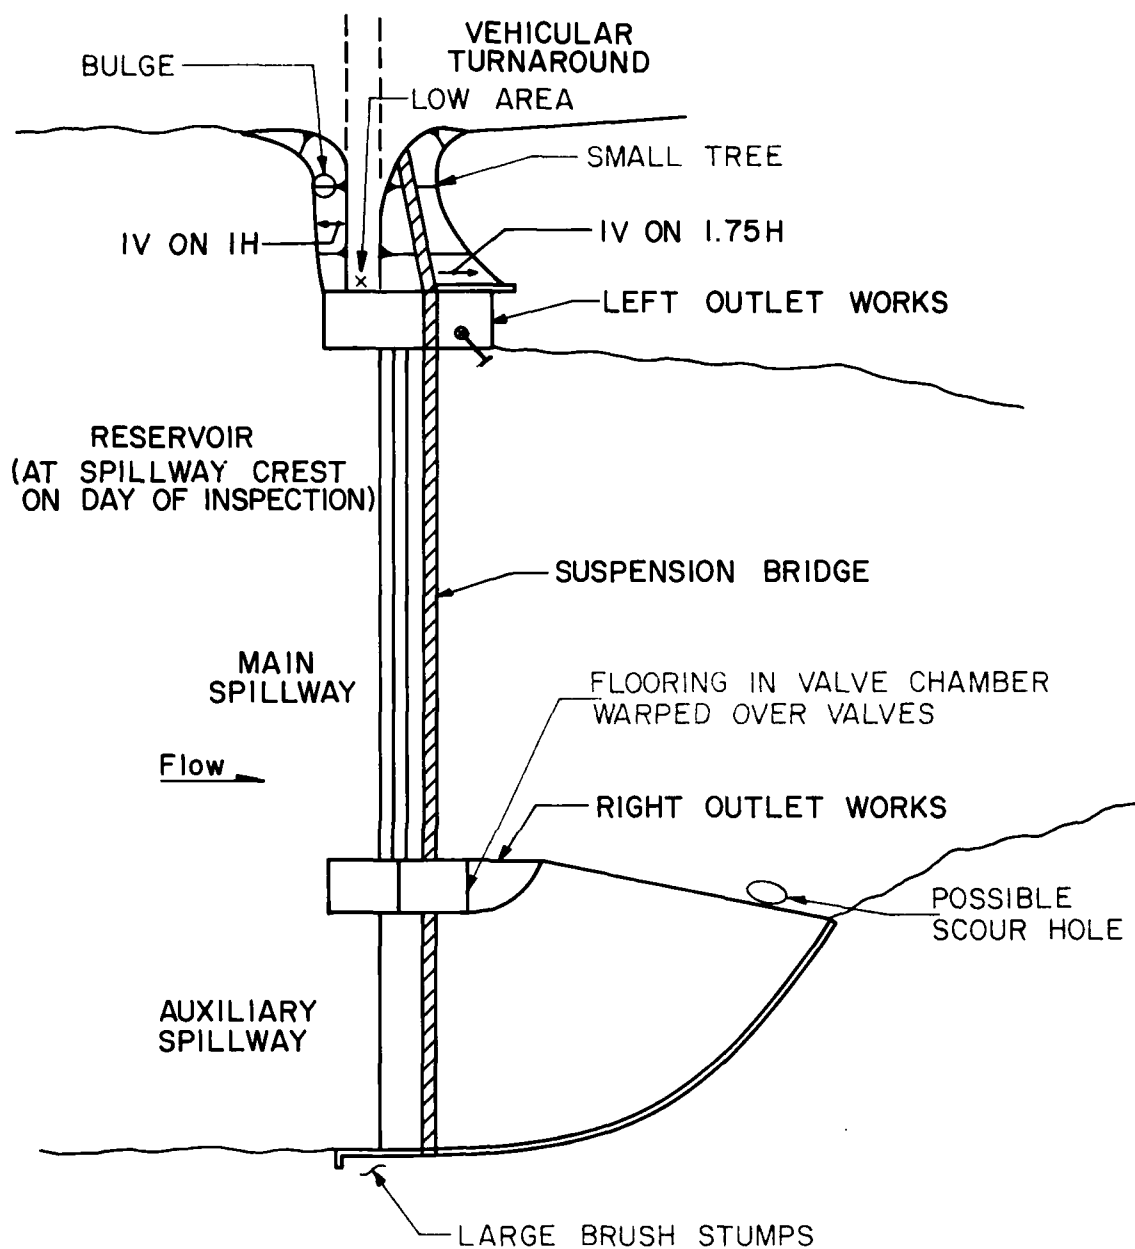
PHASE I INSPECTION REPORT  
NATIONAL DAM INSPECTION PROGRAM  
SPRING BROOK INTAKE DAM  
PENNSYLVANIA GAS  
AND WATER COMPANY  
RESULTS OF  
VISUAL INSPECTION  
APRIL 1980 EXHIBIT B-1

a. General. The overall appearance of the dam is good. Some deficiencies were observed as noted below. A sketch of the dam with the locations of deficiencies is presented on Exhibit B-1 in Appendix B. Survey information acquired for this Report is summarized in Appendix B. Datum for the survey was taken at the main spillway crest, Elevation 910.0, as shown on USGS mapping. The Owner uses a different datum. To convert the elevations on the Plates in Appendix E, 794.1 feet must be added to the elevations on those Plates. On the day of the inspection, the pool was at the spillway crest level. The dam was revisited about 2 weeks after the inspection so that additional photographs could be obtained. The spillway discharge shown on the photographs is significantly greater than the discharge that was occurring on the day of the inspection. During the revisit, it was noted that the Owner had regraded the top of the embankment. He subsequently reported that the regrading had been performed when a chlorine line to the water supply facilities was installed. He did not have any elevation data for the regrading. However, the top of the embankment is higher than indicated by the profile in Appendix B.

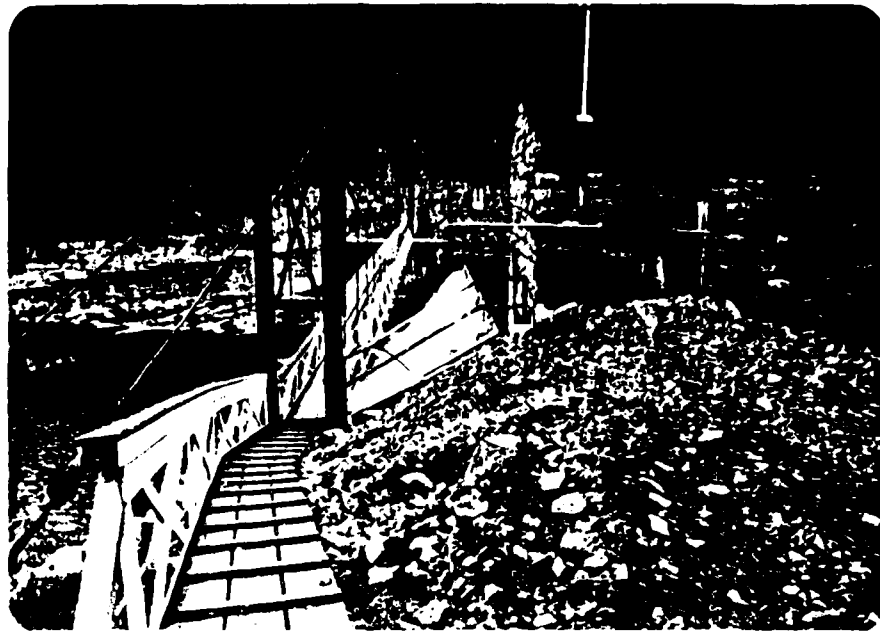
A. Embankment - Downstream Slope

(2) Embankment. The growth of the tree on the downstream slope is a minor hazard at present. Root systems of large trees can loosen embankment material, displace slope protection, and create paths along which seepage and piping (internal erosion) might occur.

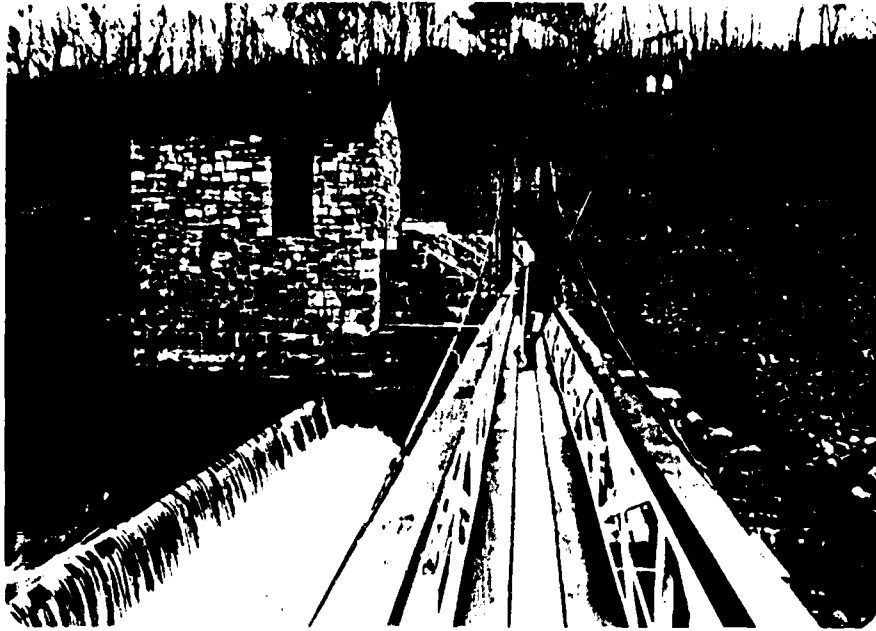
C. Left Outlet Works and Main Spillway

c. Appurtenant Structures. The main spillway and main spillway apron are in good condition (Photographs C,

E, and F). Some minor deterioration of some mortar was evident. The auxiliary spillway and auxiliary spillway apron are also in good condition, with the mortar in approximately the same condition as the main spillway (Photographs G and H). Probing with a rod indicated that a hole about 8 feet deep exists at one location immediately downstream of the downstream end of the auxiliary spillway apron. Fairly large brush stumps were observed at the right abutment of the dam.

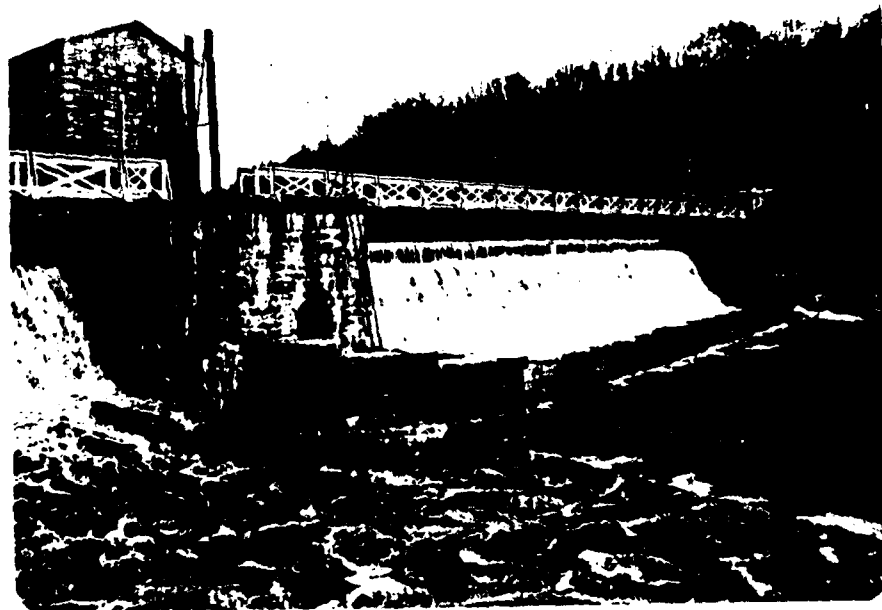
F. Main Spillway and Right Outlet Works

The right outlet works intake chamber is in good condition. Electrical work was in progress for the installation of the travelling screen, as noted in Paragraph 1.2g. The timber flooring in the valve chamber is warped severely, making access to the valves very difficult. Leaching is evident on both the interior and exterior walls of the structure.

(3) Repair the flooring in the right outlet works valve chamber and ensure the operational adequacy of the emergency drawdown valve. Operate it on a regular basis.
